BEFORE YOU BUY
BEFORE YOU BUILD

NZ Asbestos Inspection and Condition Report (Sampling)

Inspection Date: Thu, 7 Nov 2024

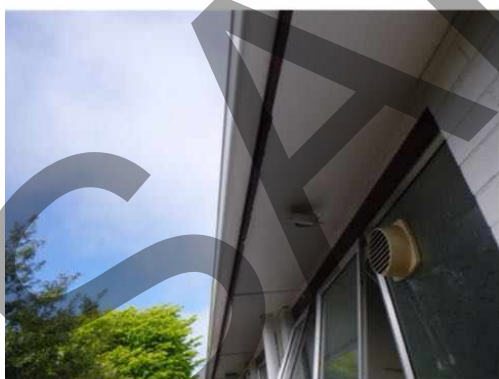
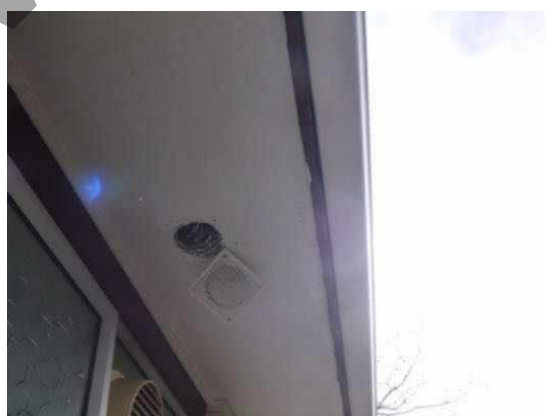
Asbestos, Asbestos Containing Materials and Asbestos Dust 4.01

Building: Main Building
 Location: Roof Exterior > All Areas
 Finding: Asbestos - ACM Confirmed (NZ)
 Information: Samples of suspected Asbestos Containing Material (ACM) were removed from the building for analysis by a IANZ accredited laboratory. The sample results confirmed that the material/s tested do contain Asbestos. The results indicated that the type of Asbestos is (White Chrysotile or Brown Amosite or Other).

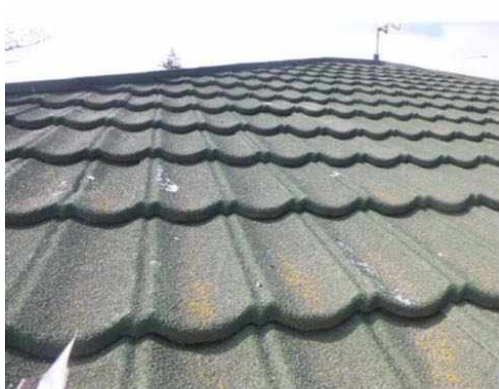
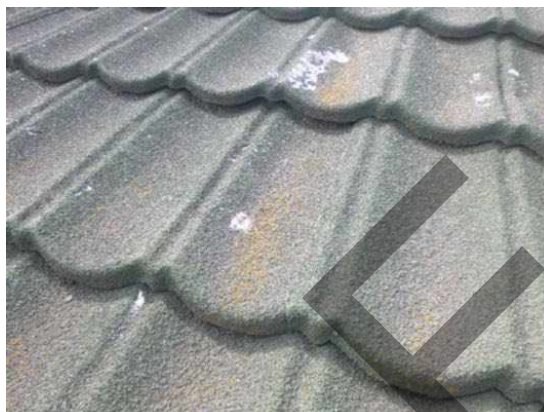
Asbestos, Asbestos Containing Materials and Asbestos Dust 4.02

Building: Main Building
 Location: Roof Exterior > All Areas
 Finding: Asbestos - ACM Confirmed (NZ)
 Information: Samples of suspected Asbestos Containing Material (ACM) were removed from the building for analysis by a IANZ accredited laboratory. The sample results confirmed

that the material/s tested do contain Asbestos. The results indicated that the type of Asbestos is (White Chrysotile or Brown Amosite or Other).

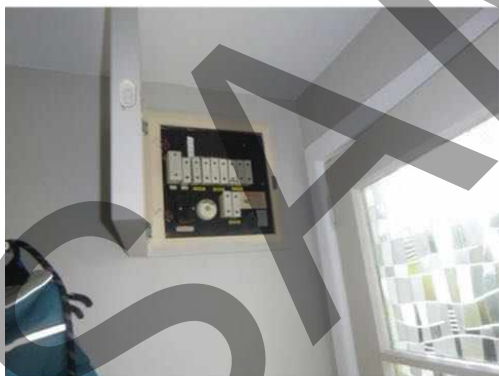
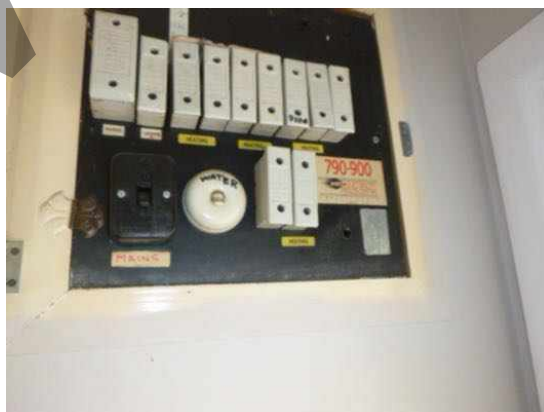
Asbestos, Asbestos Containing Materials and Asbestos Dust 4.03

Building: Main Building
 Location: Entry > Centre
 Finding: Asbestos - ACM Confirmed (NZ)
 Information: Samples of suspected Asbestos Containing Material (ACM) were removed from the building for analysis by a IANZ accredited laboratory. The sample results confirmed that the material/s tested do contain Asbestos. The results indicated that the type of Asbestos is (White Chrysotile or Brown Amosite or Other).

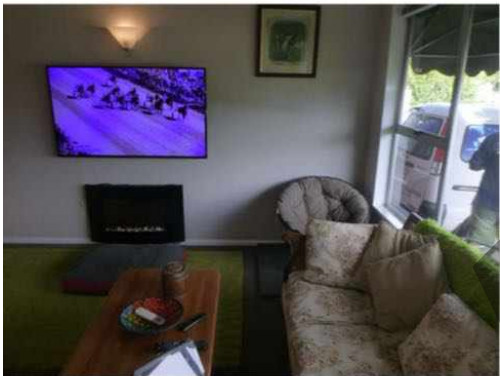
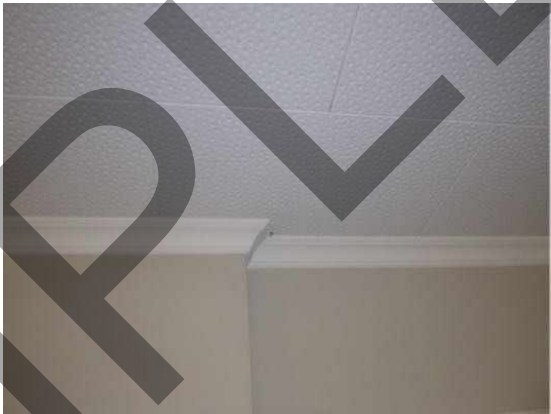
Noted Item

Building: Main Building
Location: Lounge Room > All Areas
Finding: Asbestos - Negative Lab Result (NZ)
Information: Samples of suspected Asbestos Containing Material (ACM) were removed from the building for analysis by a IANZ accredited laboratory.

The samples analysed were free of Asbestos fibres.
