# New Construction Inspection - Handover Stage

Inspection Date: Mon, 06 Oct 2014

In summary the building, compared to others of similar age and construction is in good condition with some minor defects found.

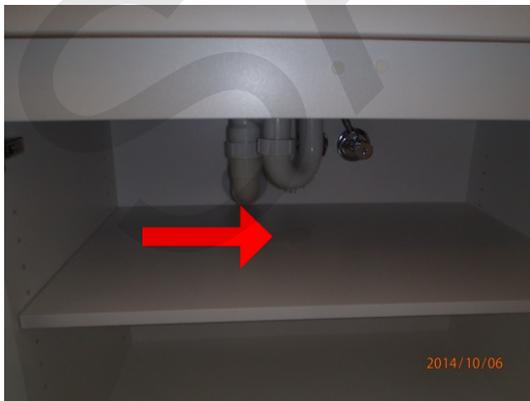
#### Defects 3.01

Building: Main Building

Location: Ensuite

Finding: Water leak - internal

Information: Internal water leaks can be detrimental to surrounding building elements. Their potential causes include damage to plumbing fittings and fixtures through to deterioration of washers.

Rust corrosion decay and water damage are potential outcomes where an even minor water leak is left unattended. More serious defects may also result e.g.: electrical hazards.

In extreme cases structural damage may develop due to a prolonged water leak. It is highly advised that internal water leaks be addressed by a licensed plumber.

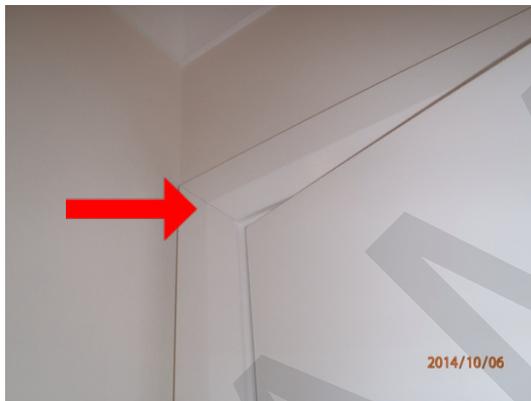
### Defects 3.02

Building:	Main Building
Location:	Bedroom - Master
Finding:	Cracking - Damage Category 1 - Fine (up to 1mm)
Information:	Although fine cracks are quite noticeable they are often only considered to be an appearance defect and usually do not indicate any structural damage. Generally the cause of a fine crack is indicative of a separation between building materials and finishes (e.g.: paint and plaster etc.) along joins.

Cracking of this nature can generally be repaired with minor sanding filling and/or repainting by a handy person or painting contractor.

Always contact a building inspector should cracks widen lengthen or become more numerous.

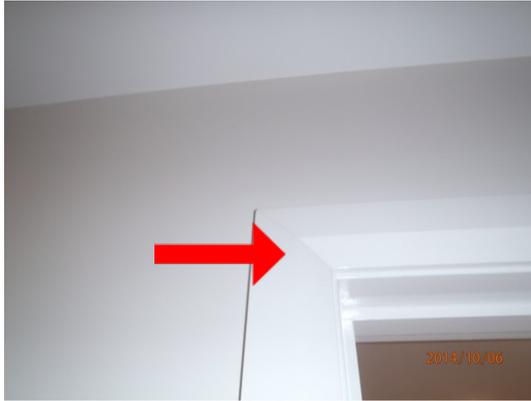
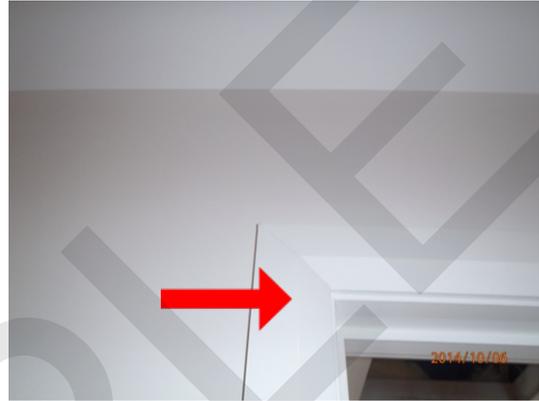
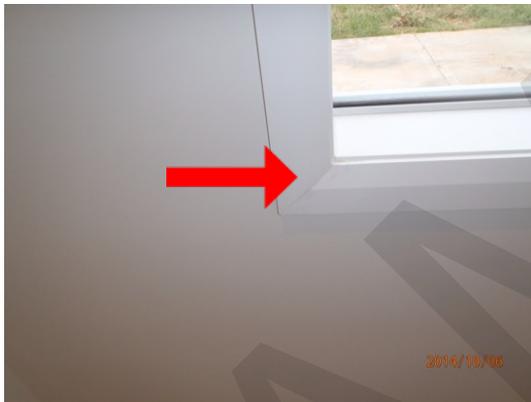
### Defects 3.03

Building:	Main Building
Location:	All Areas
Finding:	Cracking - Damage Category 1 - Fine (up to 1mm)
Information:	Although fine cracks are quite noticeable they are often only considered to be an appearance defect and usually do not indicate any structural damage. Generally the cause of a fine crack is indicative of a separation between building materials and finishes (e.g.: paint and plaster etc.) along joins.

Cracking of this nature can generally be repaired with minor sanding filling and/or repainting by a handy person or painting contractor.

Always contact a building inspector should cracks widen lengthen or become more numerous.

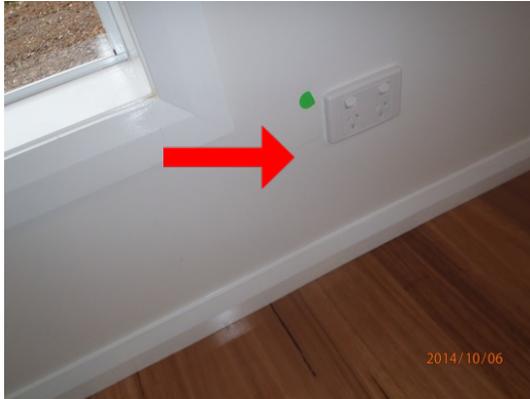
### Defects 3.04

Building: Main Building

Location: Bedroom 4

Finding: Plasterboard finish - defective

Information: The finish of the plasterboard in the identified area is defective as it falls below Level 4 category finish as defined in AS 2589.1 Section 6.6 Levels of Finishes for Plasterboard Surfaces. The key features of a Level 4 finish include: joints and fasteners adequately concealed joints and interior angles to have tape embedded in joint compound and at least 2 coats of joint compound to each joint angle fasteners accessories. A level 4 finish should be smooth and free of tool marks or Ridges

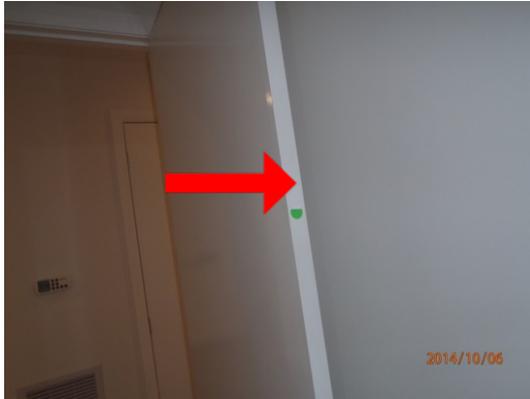
### Defects 3.05

Building: Main Building

Location: Bedroom 2

Finding: Paint finish - substandard

This is generally an appearance defect but may be indicative of poor surface preparation and substandard workmanship. If this applies further areas of poor and incomplete finishes could develop over time. Furthermore substandard paint finishes in areas exposed to moisture e.g. external areas or wet areas could lead to deterioration of underlying building materials.

Substandard paint finishes should be sanded back filled levelled and repainted as applicable. Where inadequate paint protection has led to the deterioration of the associated building element repair and/or replacement of this building element may be required.

A painting contractor should be appointed as soon as possible to perform necessary works to aid the appearance of the affected area and to ensure the area is protected against further deterioration. Alternatively the homeowner following manufacturers instructions may be able to provide this service.

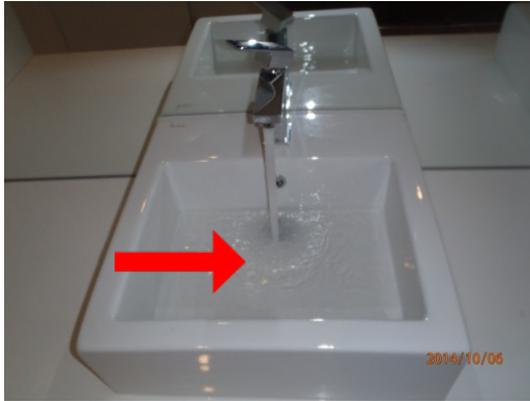
### Defects 4.01

Building:	Main Building
Location:	Bathroom
Finding:	Basin - blocked
Information:	The basin in this area appeared to be blocked upon inspection. Blockages prevent building elements from operating as intended and if left unmanaged a lack of general maintenance may lead to the development of more significant defects such as water damage to surrounding building materials.

It is advised the cause of the blockage be removed check for any secondary or concealed damage and then attempt to address the cause of the blockage to prevent any water damage to associated structures.

A licensed plumber should be appointed as soon as possible to remove the blockage and to perform any remedial works as necessary. Please be advised that a cabinet maker or qualified carpenter may be required if water damage is evident.

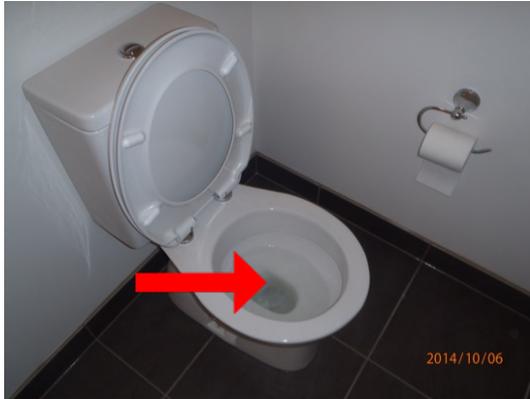
## Defects 4.02

Building:	Main Building
Location:	Bathroom
Finding:	Blocked
Information:	Blockages prevent building elements from operating as intended and if left unmanaged the lack of general maintenance may lead to the development of more significant defects such as damage to surrounding building materials.

Blockages should be removed and addressed as they will lead to the development of secondary building defects. Remove the blockage check for any secondary or concealed damage and then attempt to address the cause of the blockage to prevent recurrence or any water damage to associated structures.

Depending on the location of the blockage and the building elements affected it is usually a Licensed Plumber that is the most suitable trade.

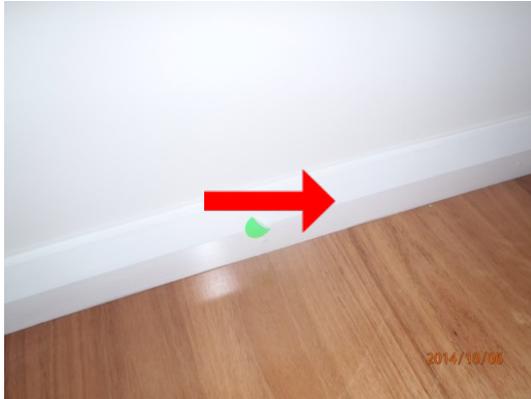
### Defects 4.03

Building:	Main Building
Location:	Bedroom 4
Finding:	Paint finish - incomplete or missing
Information:	Whilst incomplete or missing paint finish is generally an appearance defect it can also lead to the development of secondary building defects over time. Incomplete areas of paint finish exposes the area to moisture which could lead to deterioration of underlying building materials.

Incomplete paint finishes should be sanded back filled levelled and painted as applicable. Where inadequate or missing paint protection has led to the deterioration of the associated building element repair and/or replacement of this building element may be required.

A painting contractor should be appointed as soon as possible to perform necessary works to aid the appearance of the affected area and to ensure the area is protected against further deterioration. Alternatively the homeowner following manufacturers instructions may be able to provide this service.

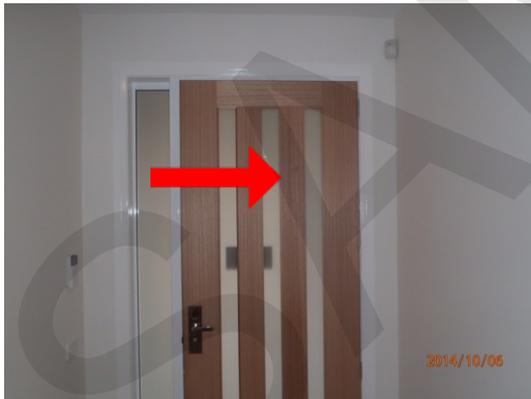
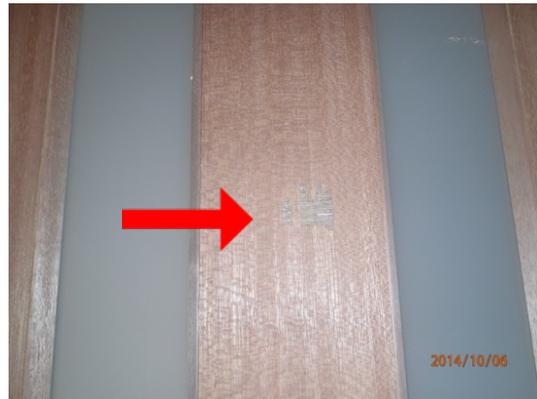
### Defects 4.04

Building: Main Building  
 Location: Entry  
 Finding: Damage front door  
 Information: Evidence of damage was identified. To front door  
 Timber veneer damaged supplier to replace

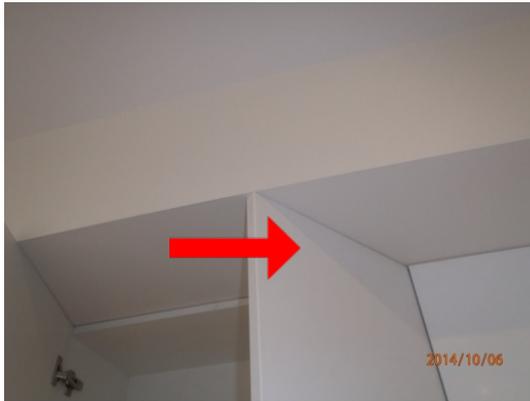
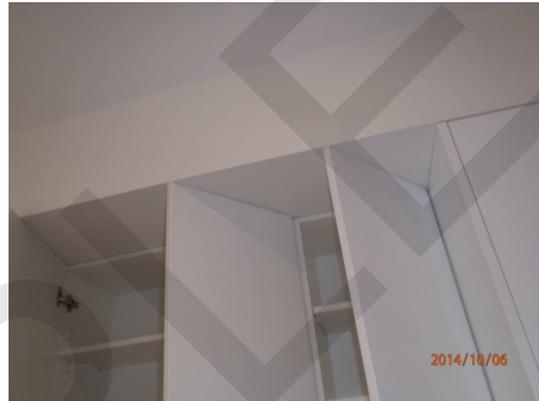
### Defects 4.05

Building: Main Building  
 Location: Kitchen

Finding: Cabinet doors - misaligned  
 Information: It is observed that some of the cabinet doors are not aligned and are rubbing on bulkhead  
 Cabinet maker to adjust

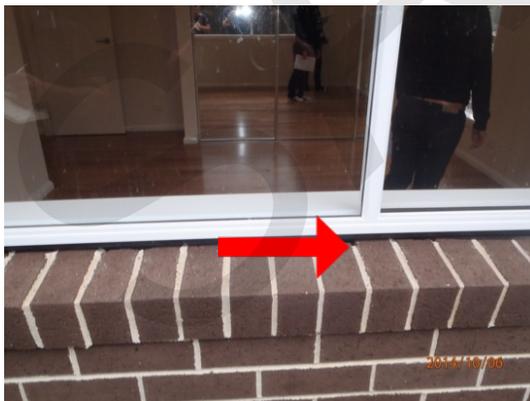
### Defects 4.06

Building: Main Building  
 Location: Yard - Side  
 Finding: Window installation not weather tight  
 Information: It was observed that the window seal / or window frame installation is defective because it can possibly allow water to penetrate rooms under wet weather conditions.  
 Builder to ensure all seals are complete and for a seal at the sill

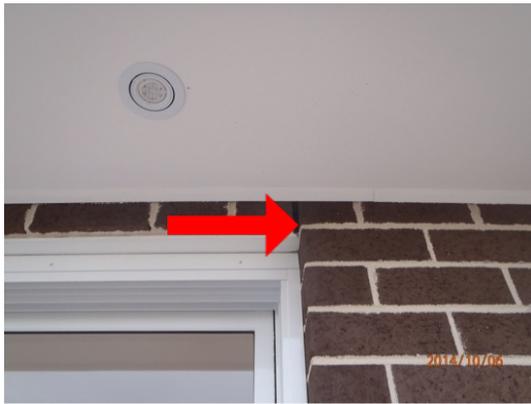
### Defects 4.07

Building:	Main Building
Location:	Yard - Side
Finding:	Sealing of masonry articulation joints - defective
Information:	It is observed that there areas of articulation joints in the masonry veneer without a cavity which are defective as they have not been sealed. It is a requirement of Standards and Tolerances that these joints be sealed.
